## Robinson Helicopter Company Accident Report

AIRCRAFT MODEL:	<u>R44 Clipper I</u>
SERIAL NUMBER:	<u>1295</u>
REGISTRATION:	<u>N7530R</u>
ACCIDENT DATE:	<u>30 January 2018</u>
ACCIDENT LOCATION:	<u>Newport Beach, California</u>
NTSB IDENTIFICATION:	<u>WPR18FA077</u>

REPORT WRITTEN BY: Ken Martin

DATE: 17 June 2019

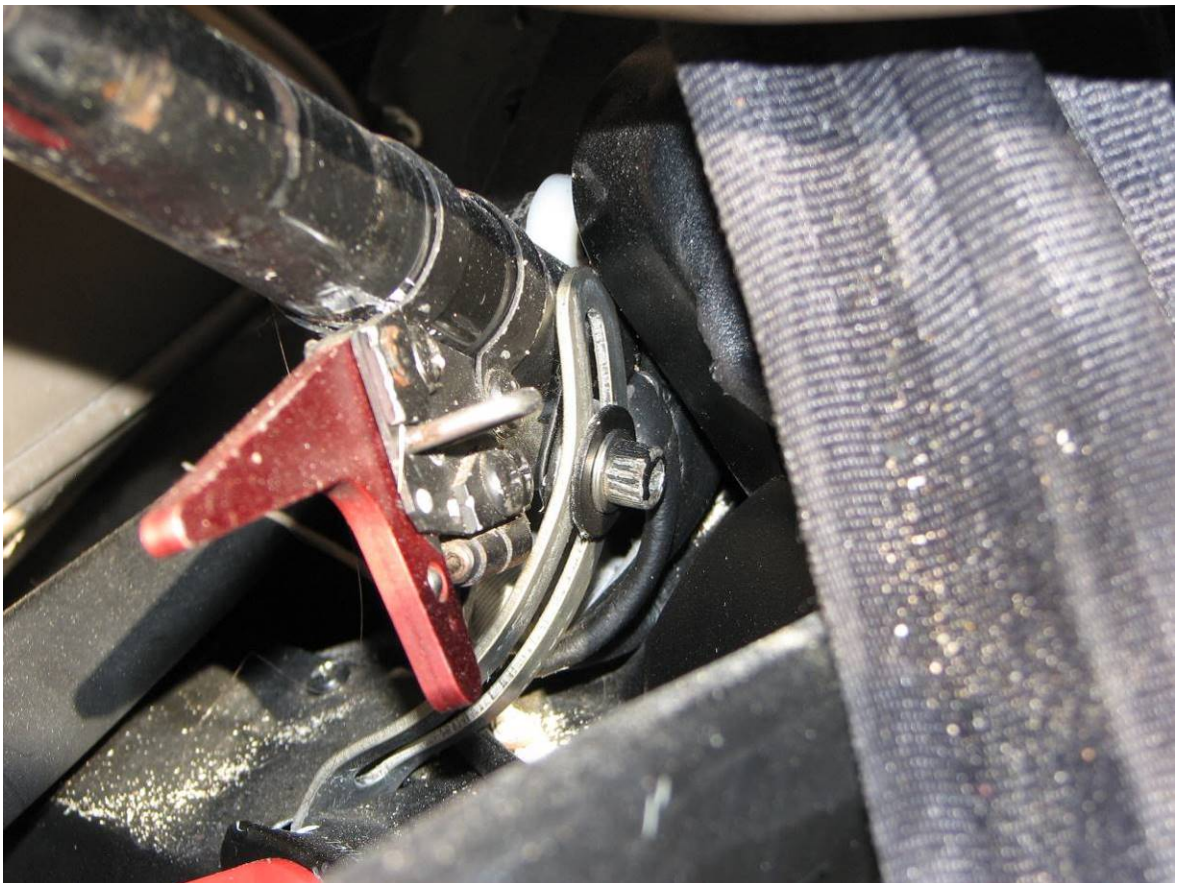
The collective friction slider

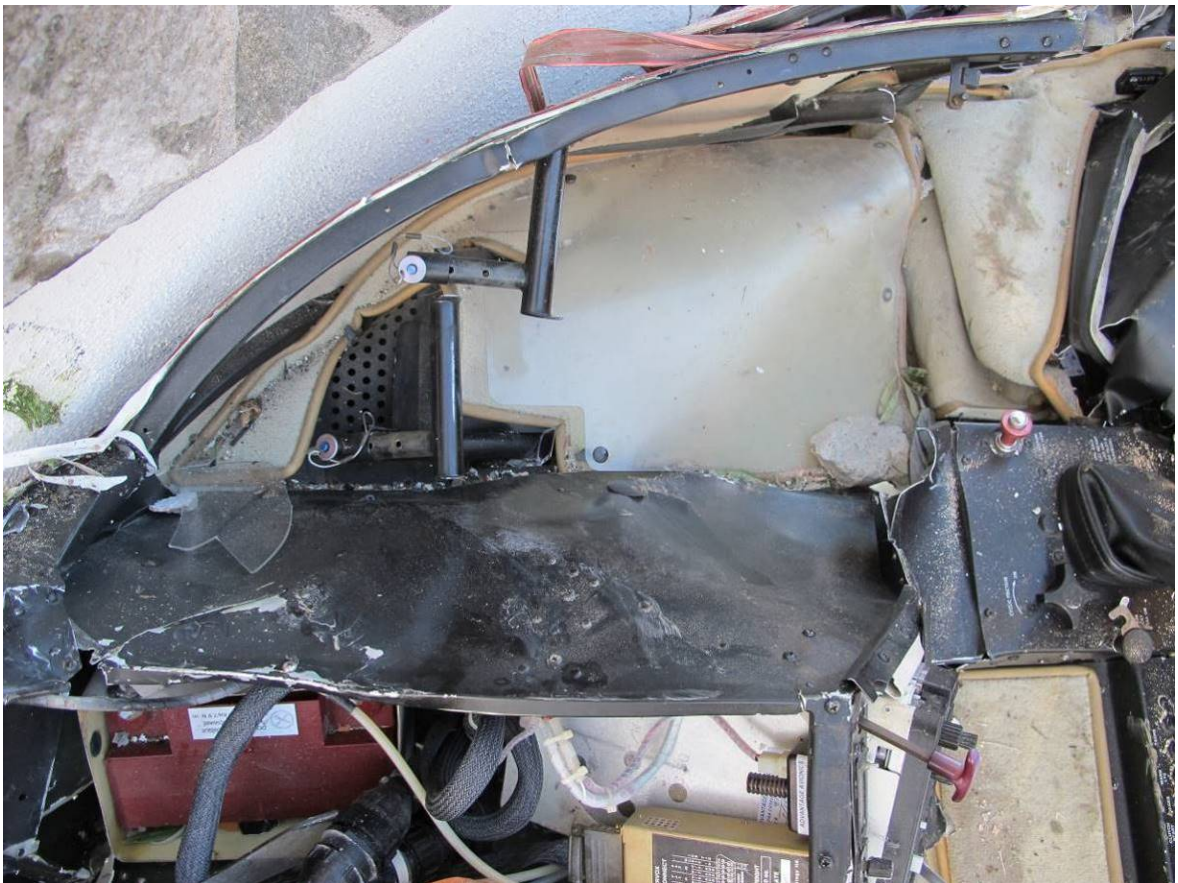
The tail rotor pedals, right seat

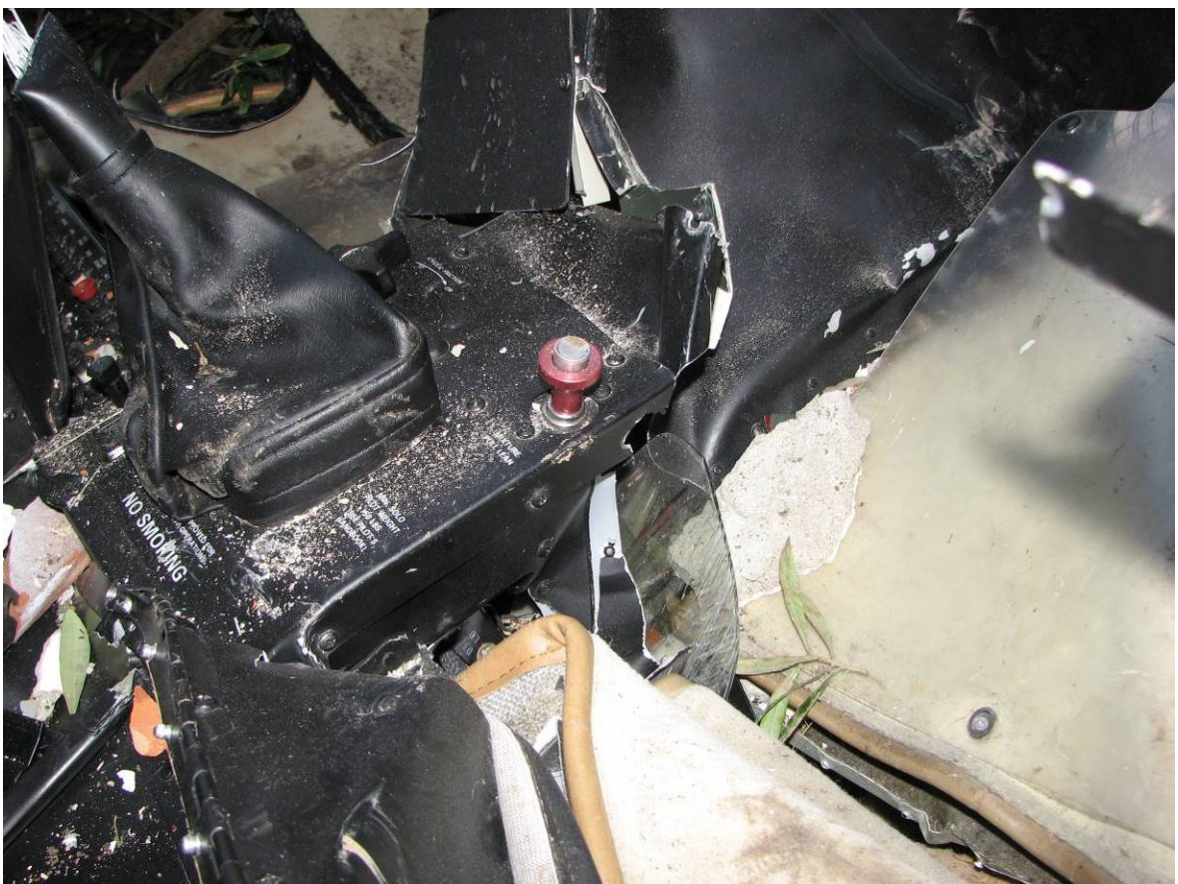
The cyclic panel and lower portion of the cyclic stick (cut by first responders)

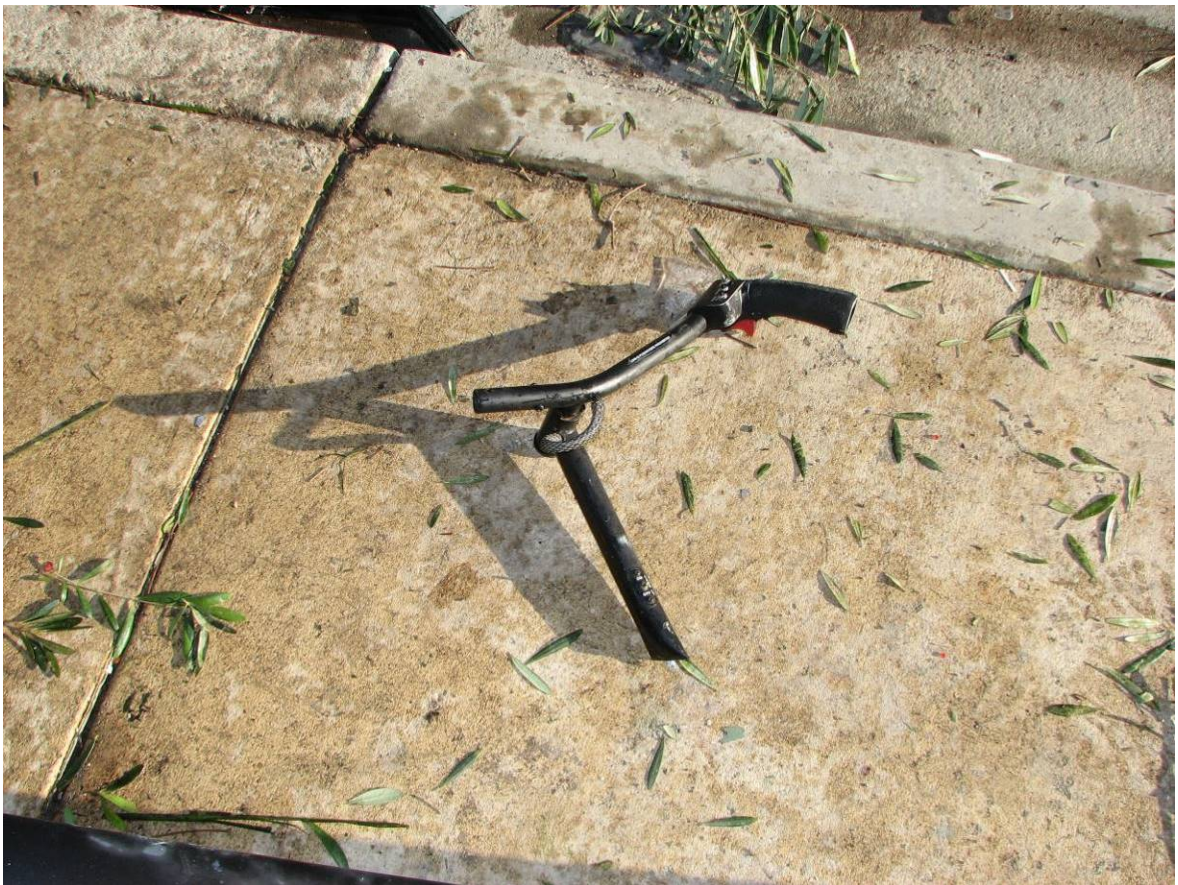
The upper portion of the cyclic stick

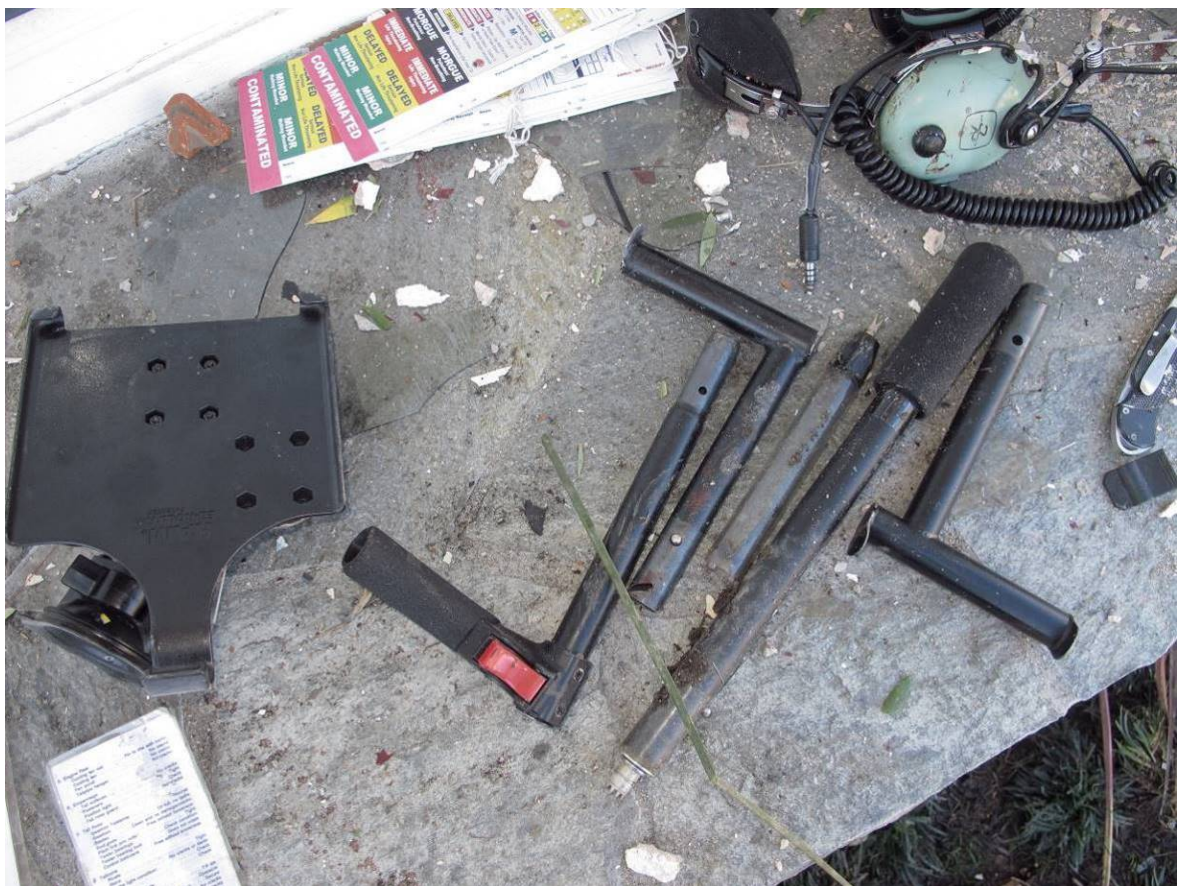
The removable controls

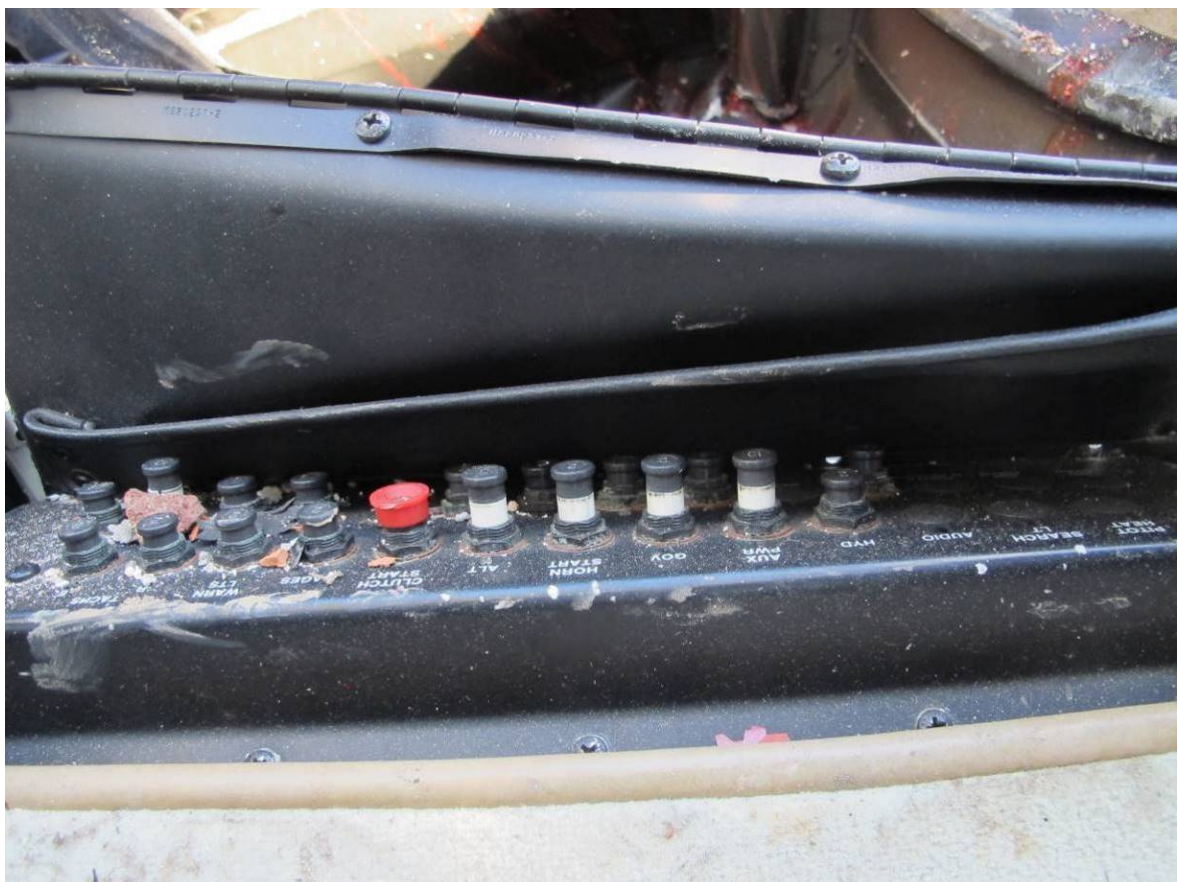
The circuit breaker panel

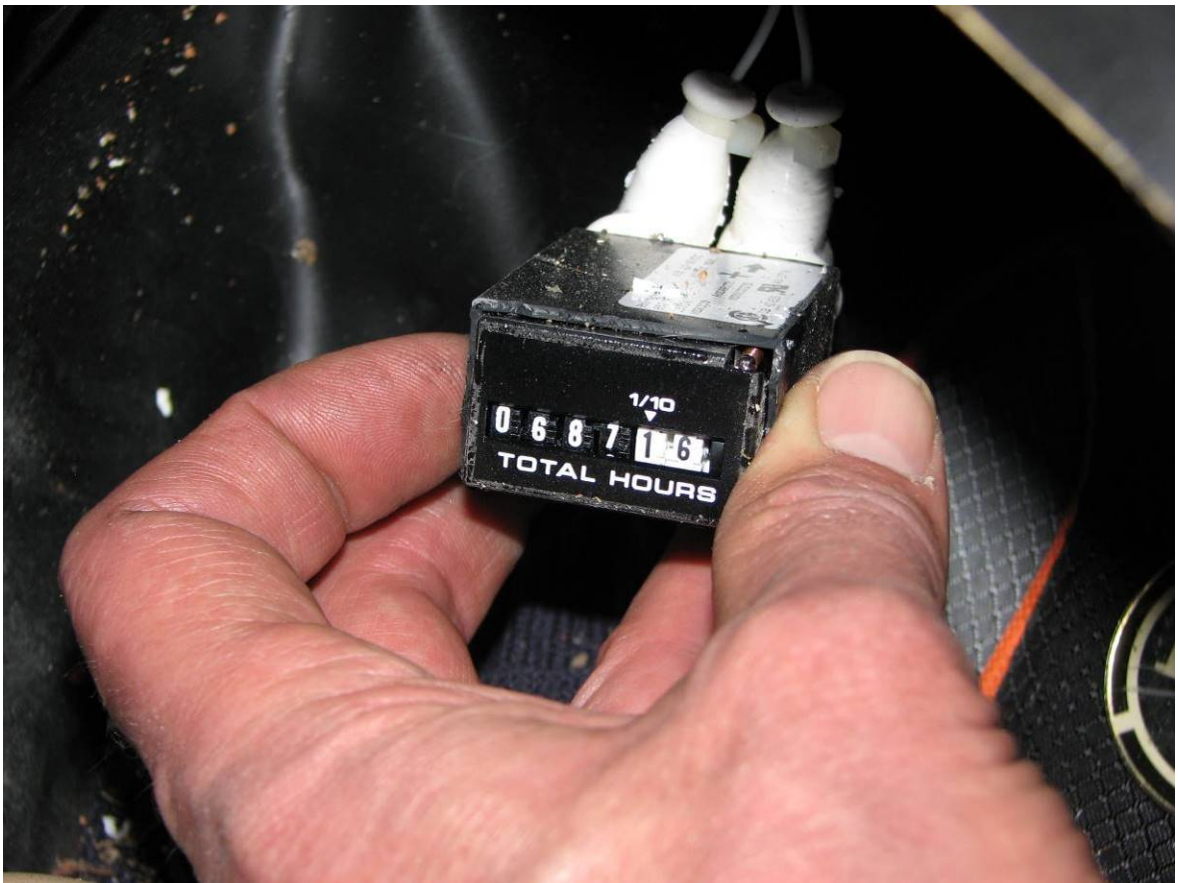
Engine hour meter

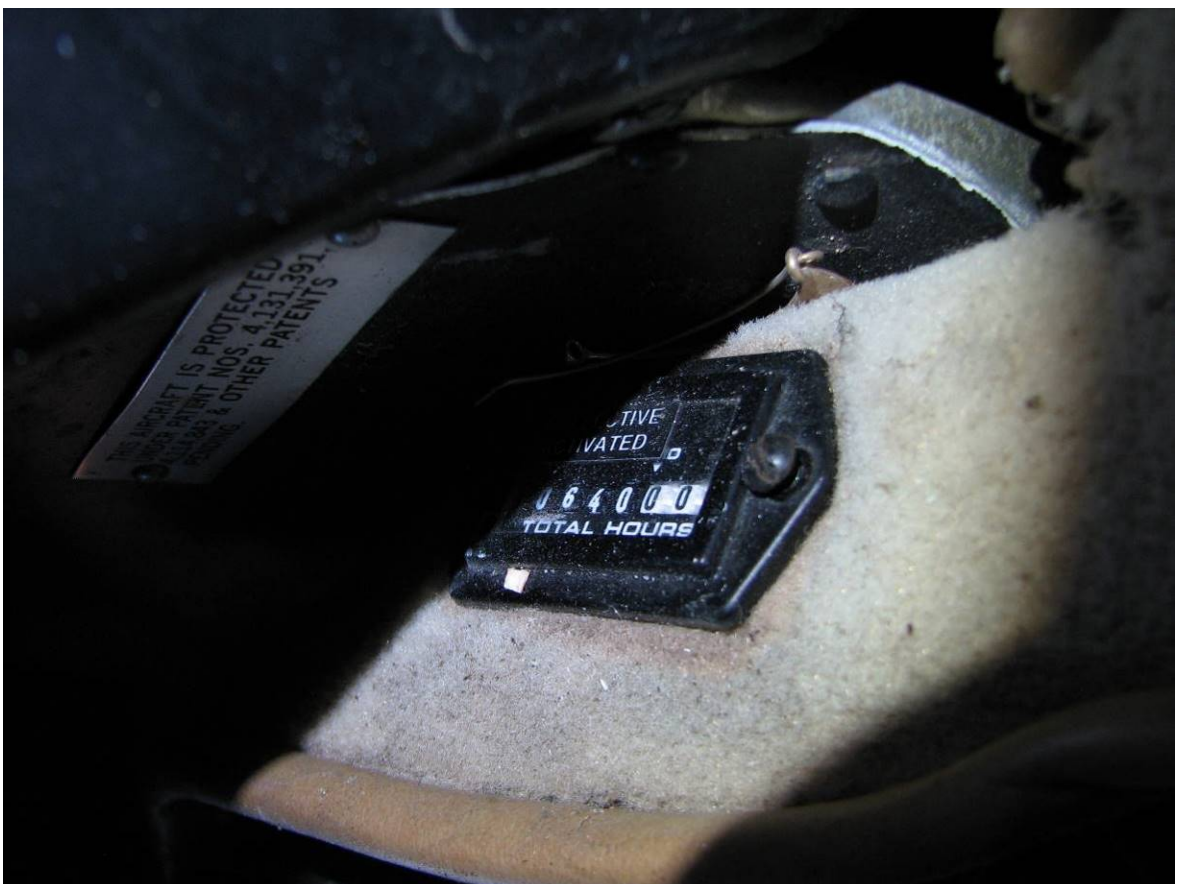
Aircraft hour meter, labeled "collective activated"

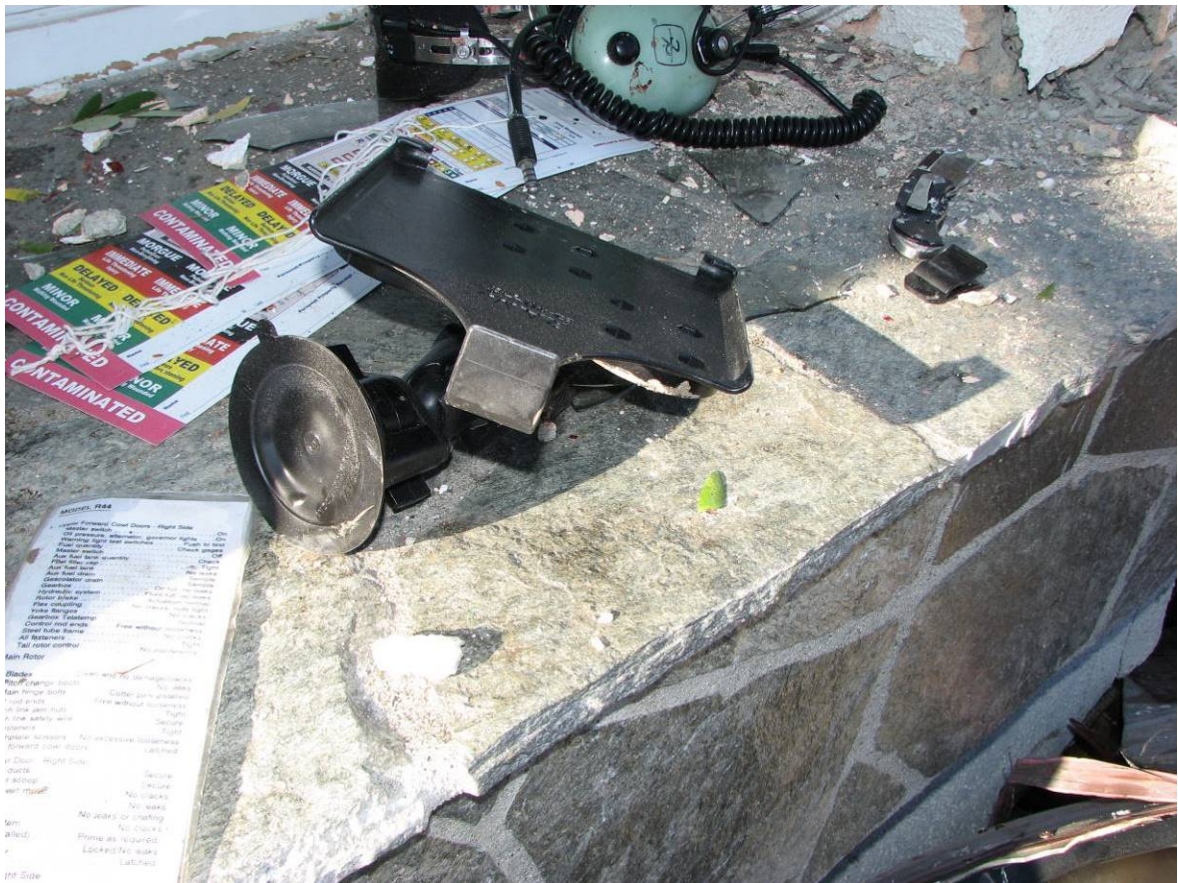
GPS or electronic device mount

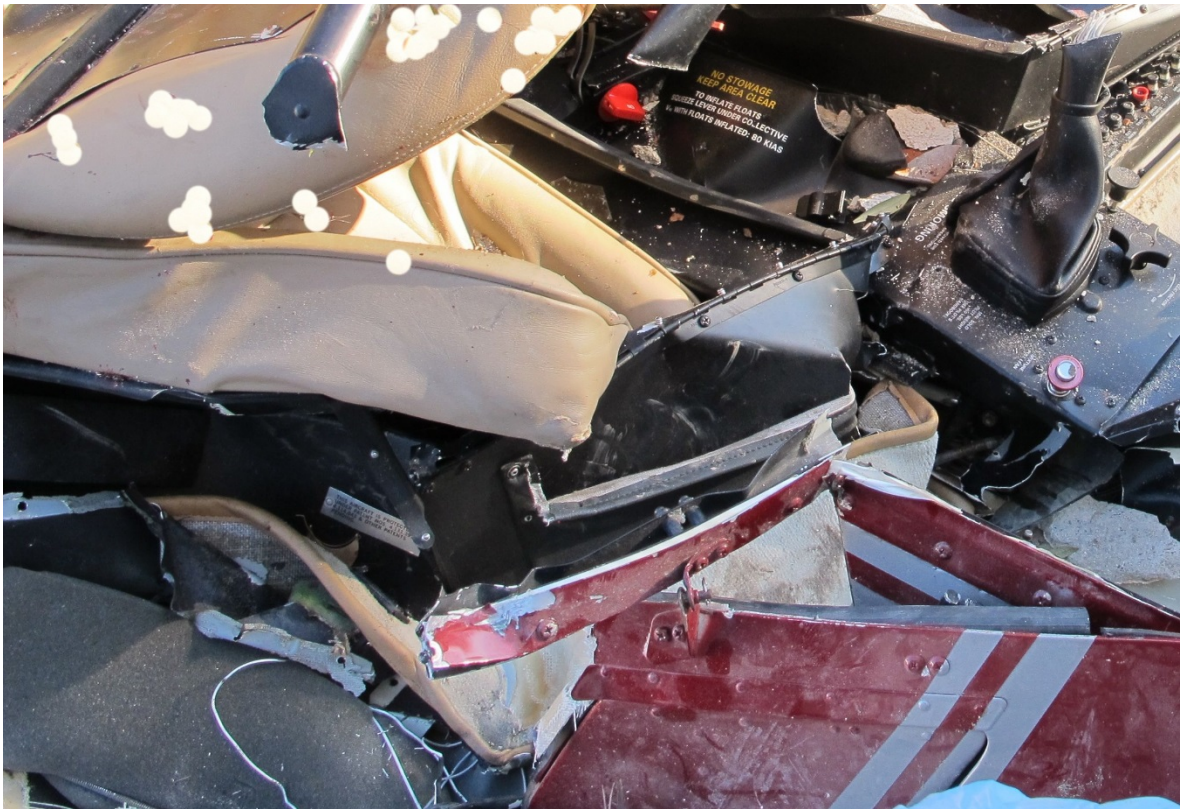
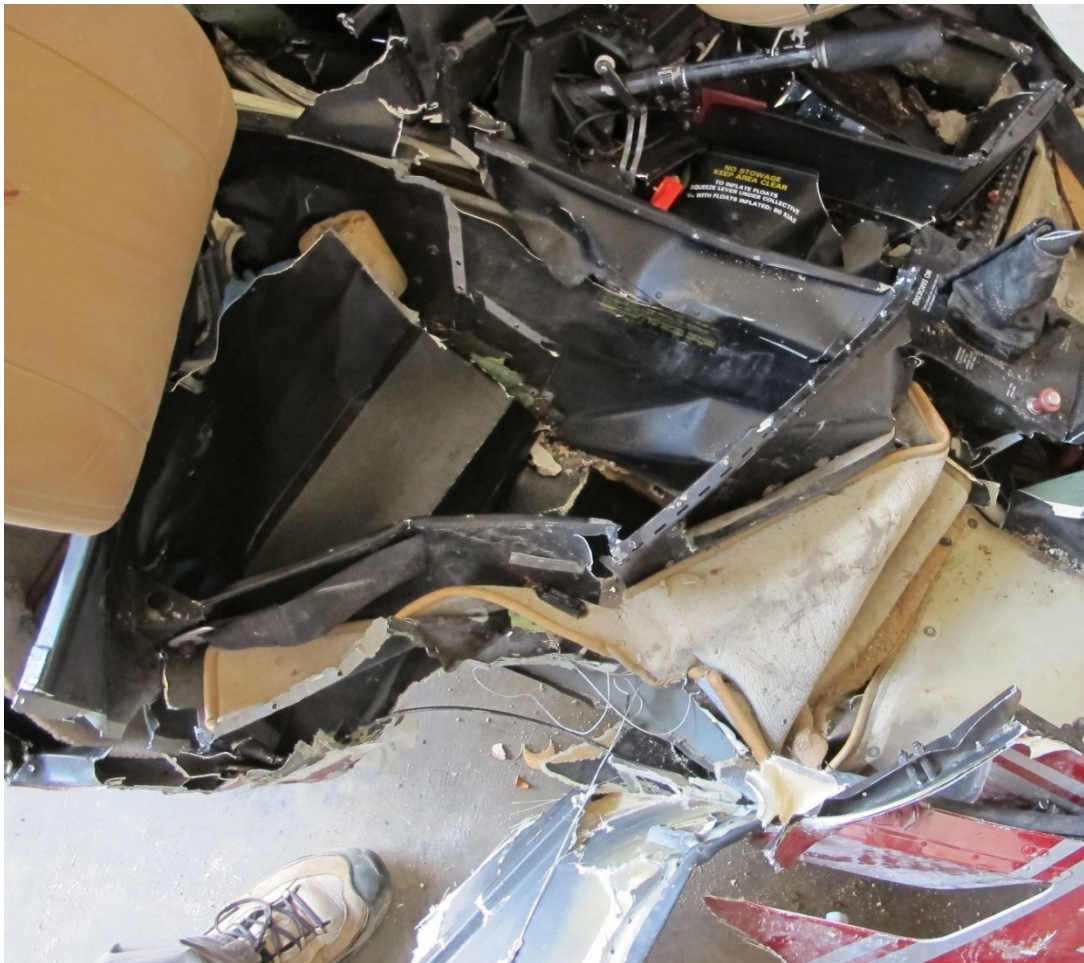
Above and below: Front right seat structure.

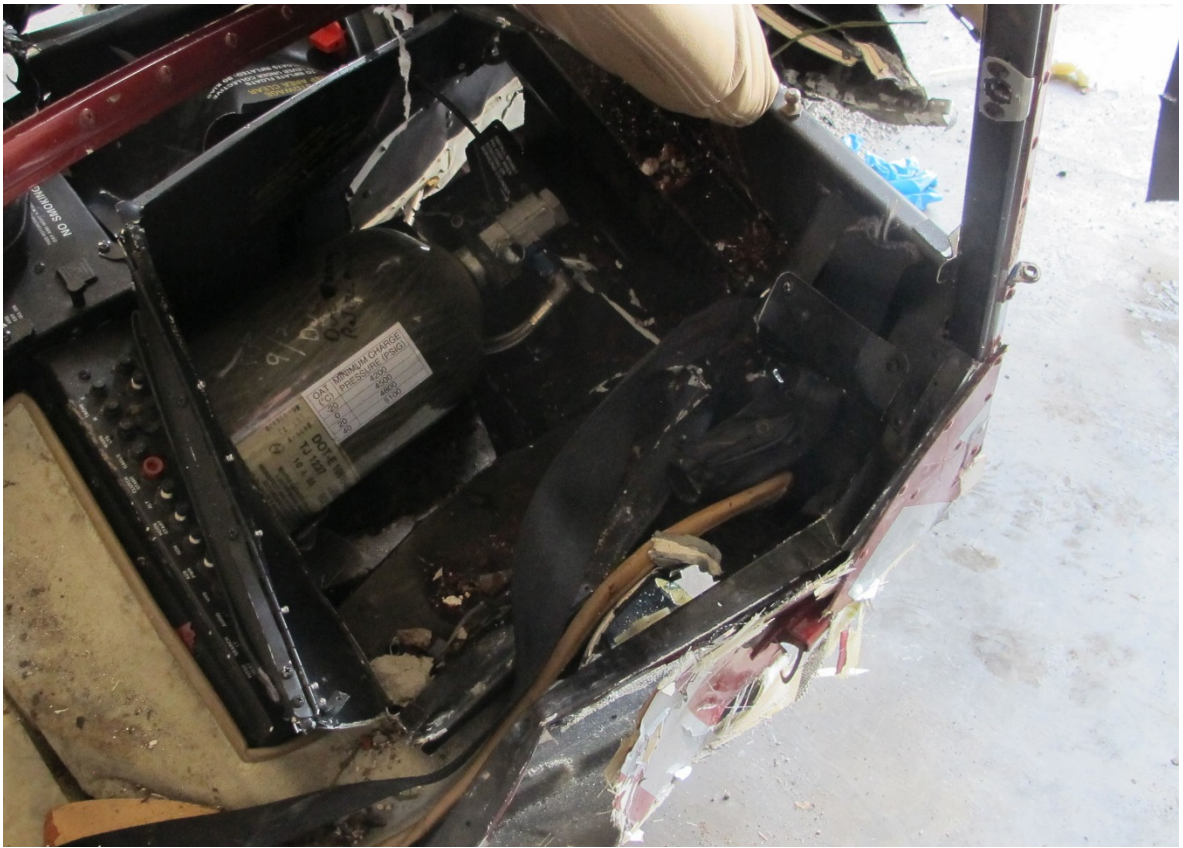
Front left seat structure.

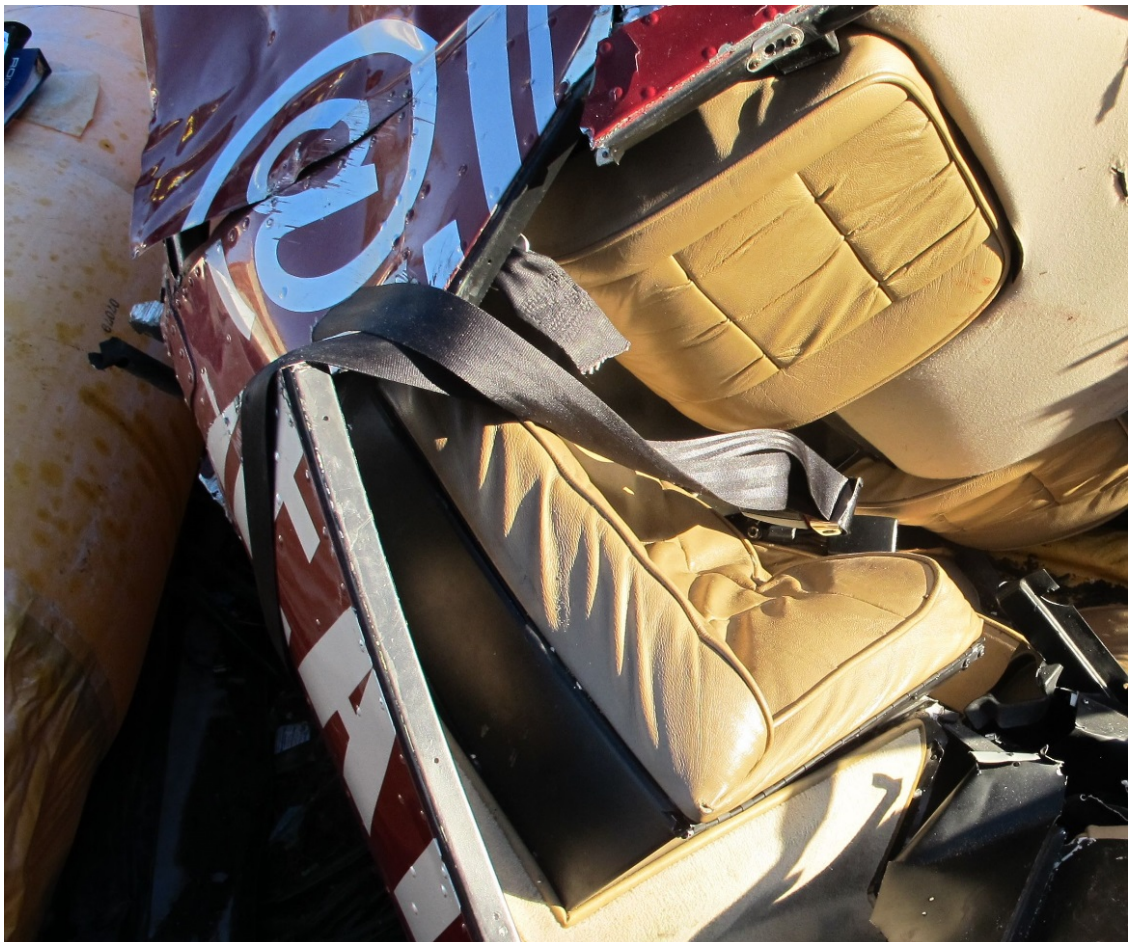
Right rear seat.

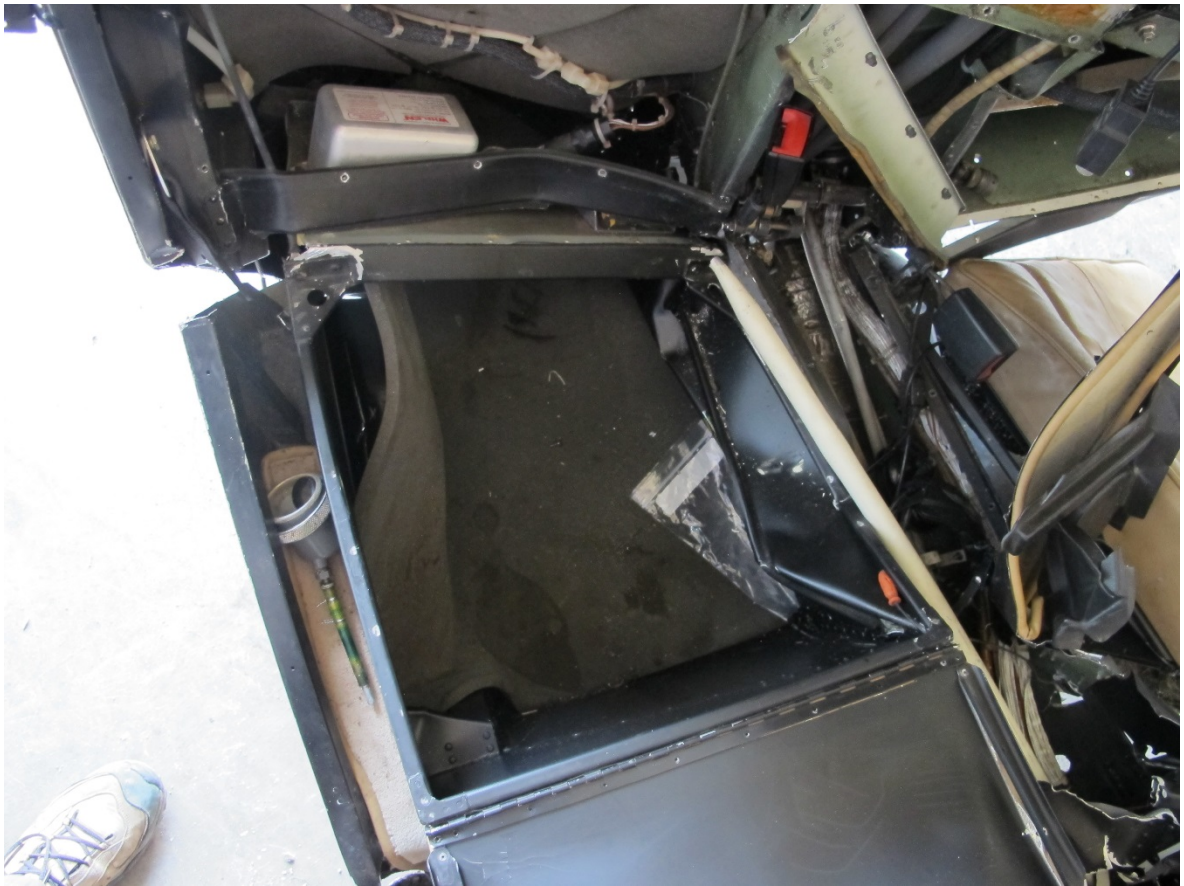
Right rear seat structure.

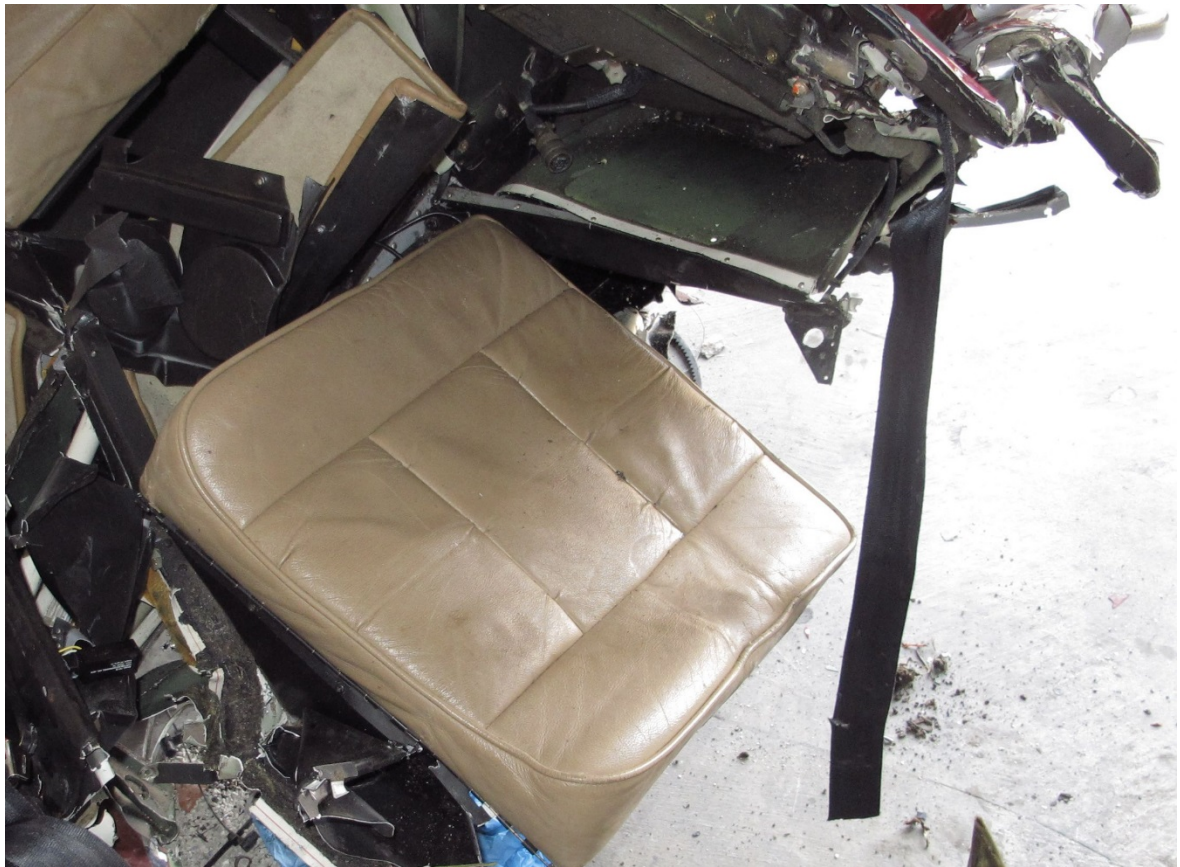
Left rear seat.

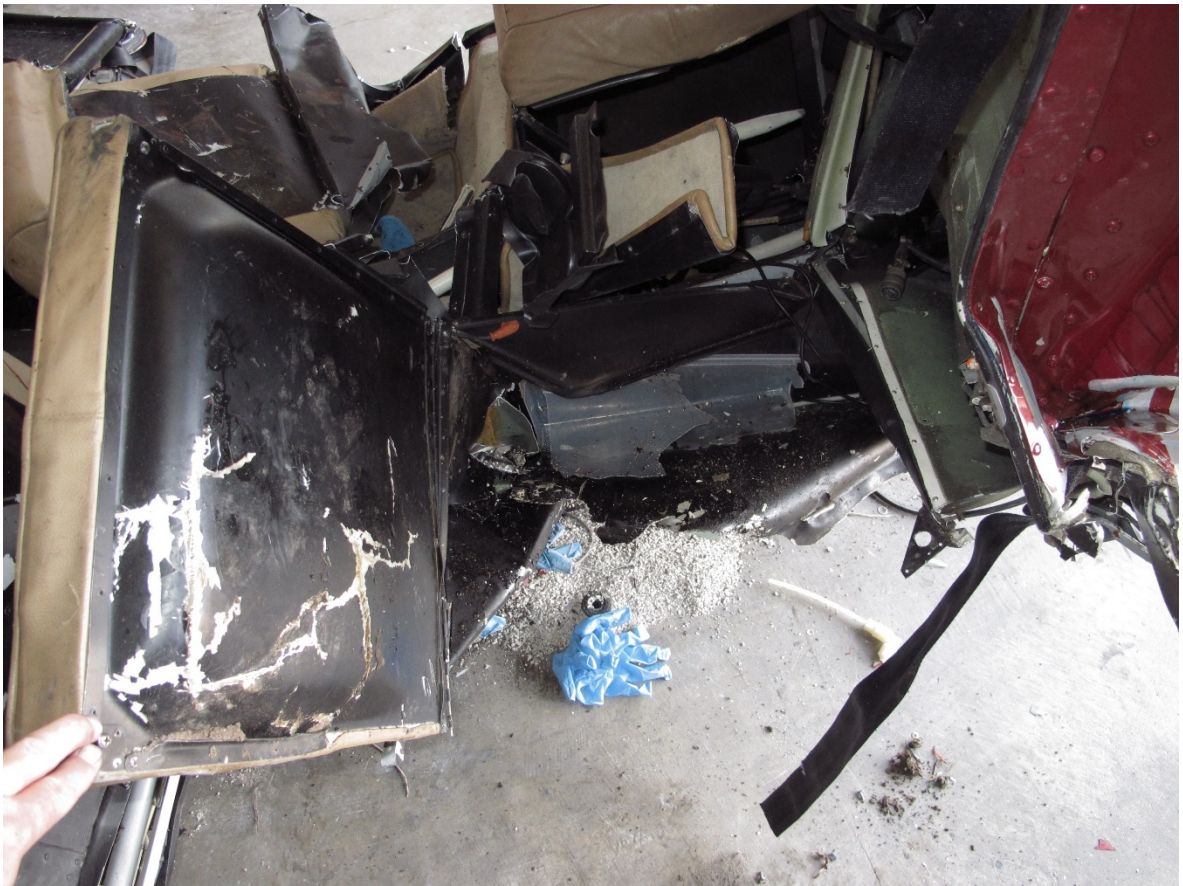
Left rear seat structure.

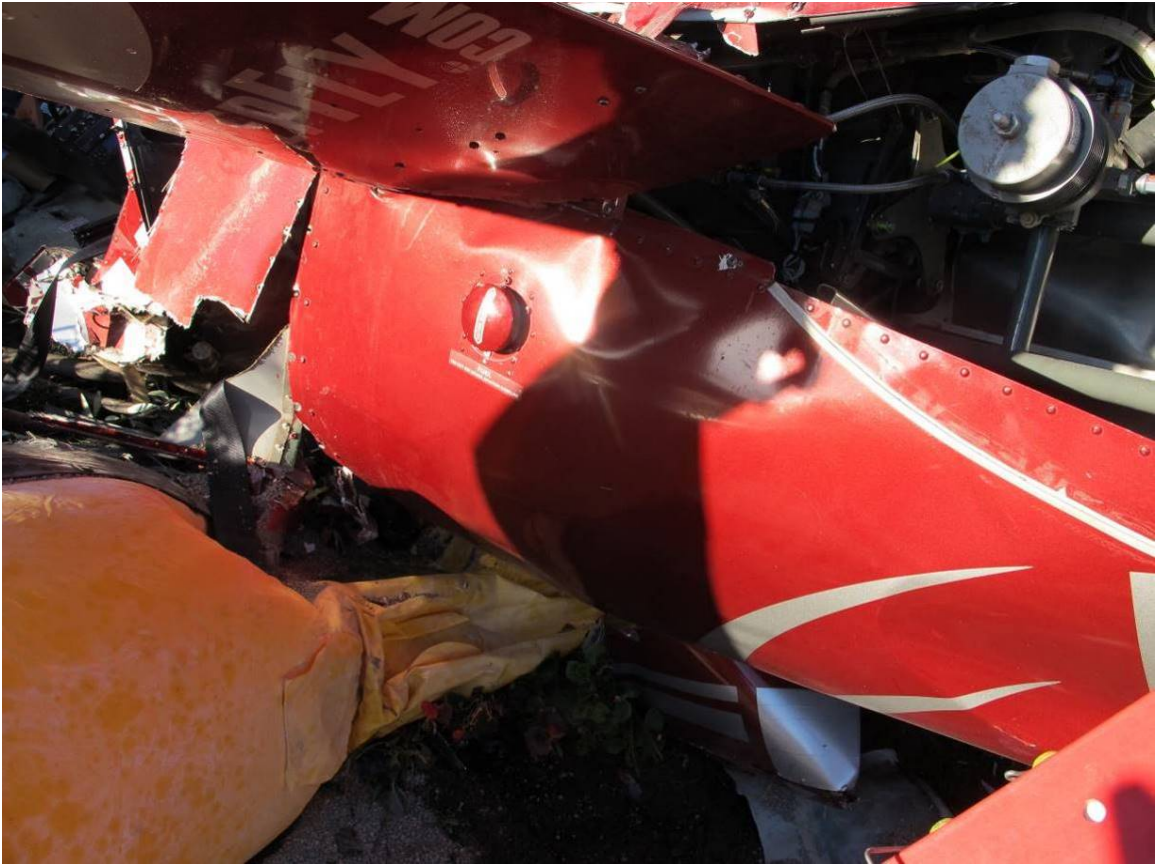
The main fuel tank remained secured to the airframe and sustained minor impact damage. The fuel cap remained secure on the filler neck.

The main fuel tank and filler cap

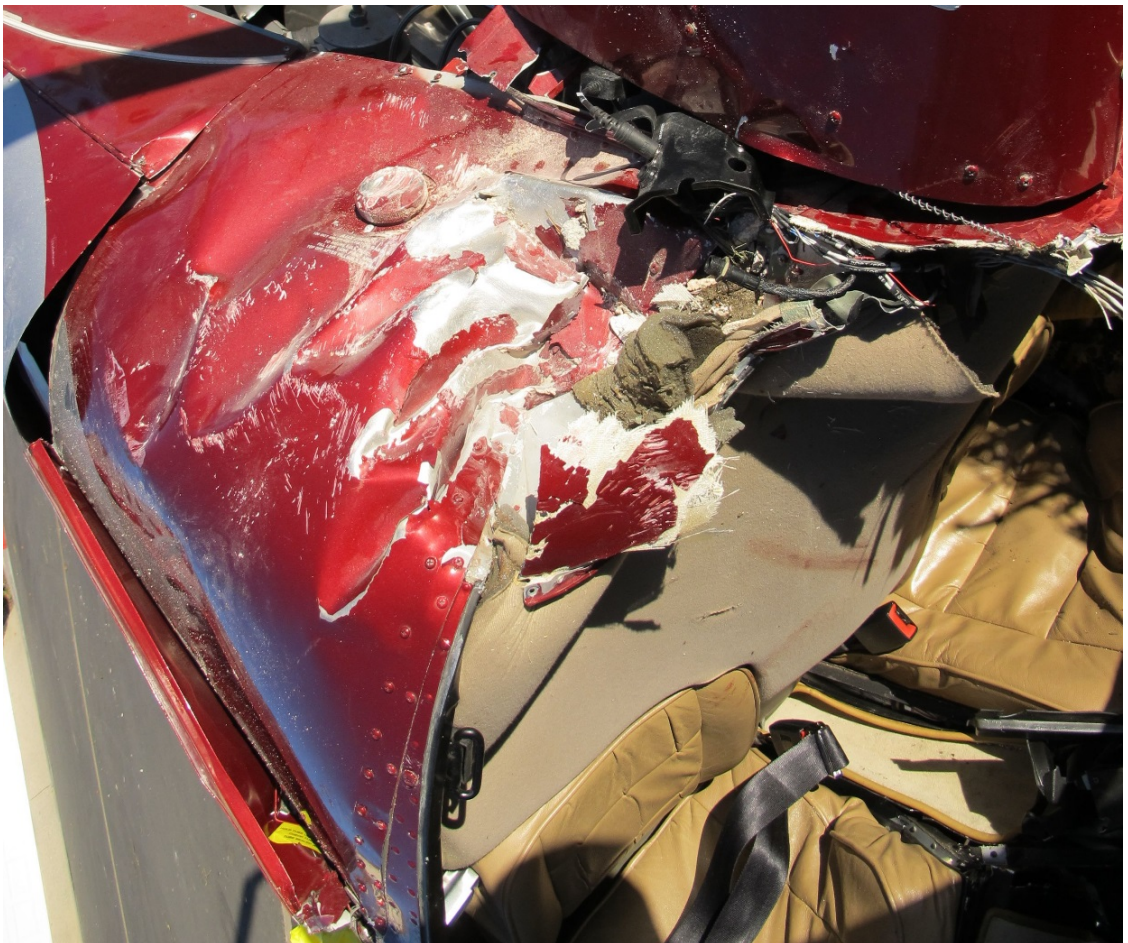
The auxiliary fuel tank remained secured to the airframe and sustained substantial impact damage to the upper and forward surfaces along with the inner surface. The fuel cap remained secure on the filler neck.

The auxiliary fuel tank and filler cap

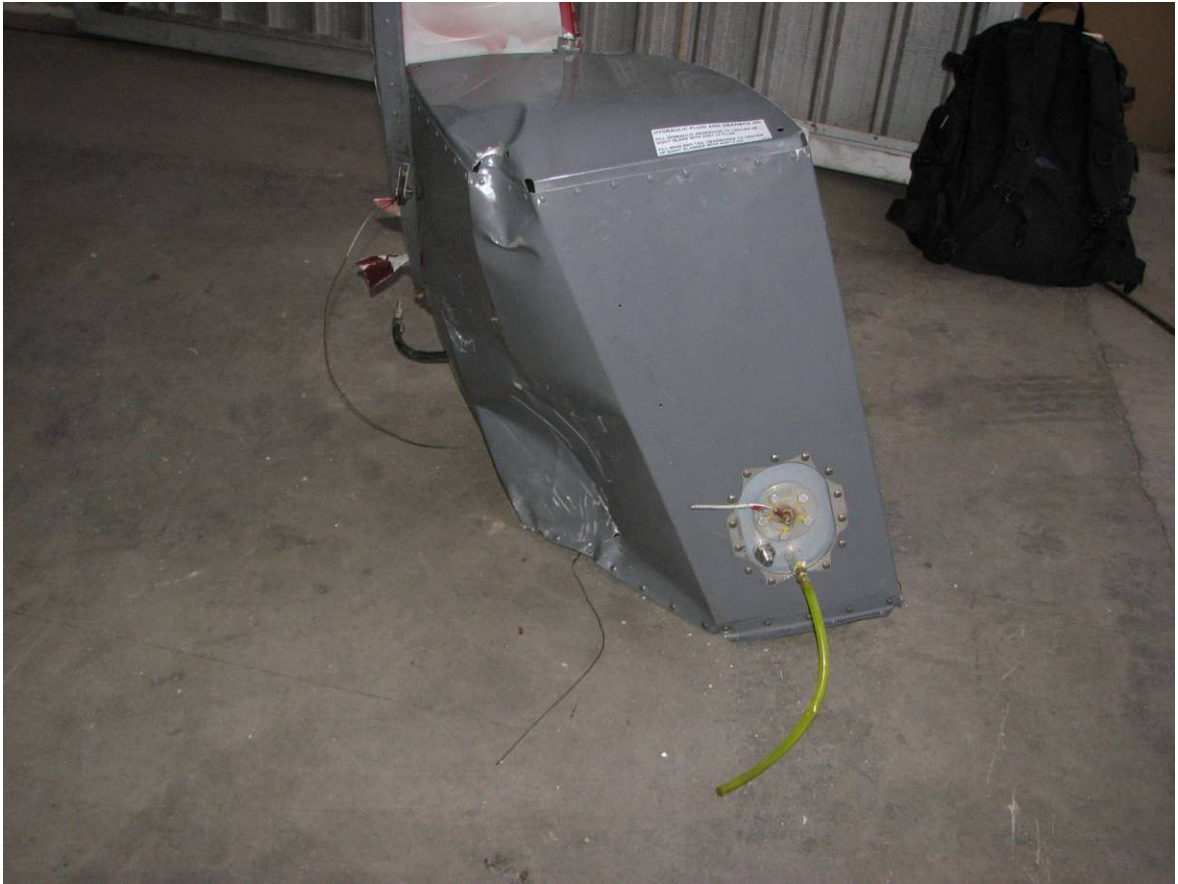
The auxiliary fuel tank, after removal from the airframe

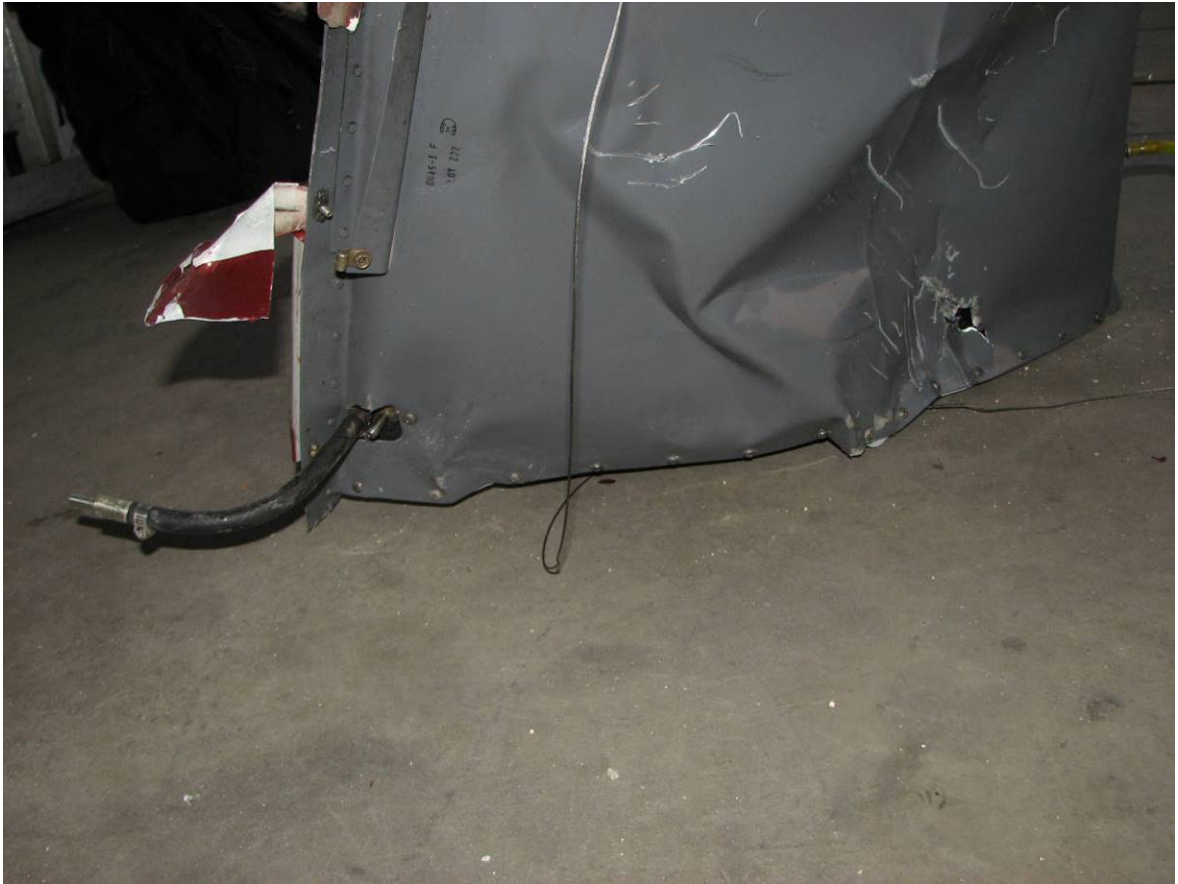
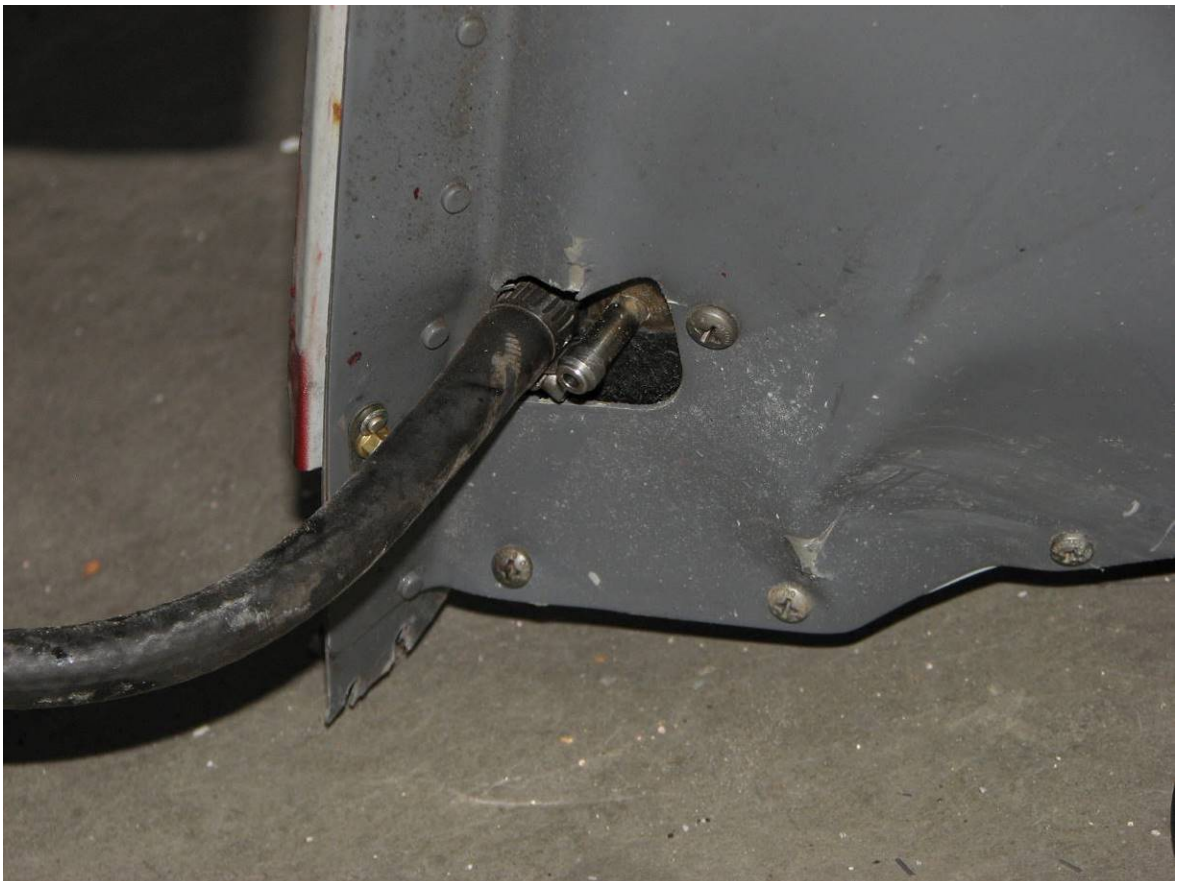
The vent line for the auxiliary fuel tank was disconnected in two places, and the tank interconnect hose was disconnected at the auxiliary tank fitting. The remaining fuel system vent hoses were intact and connected. Both check valves operated properly. All hoses, lines and tubes were determined to be clear of obstructions by blowing through the tubes.

Above and below: The vent tube fittings at the auxiliary tank

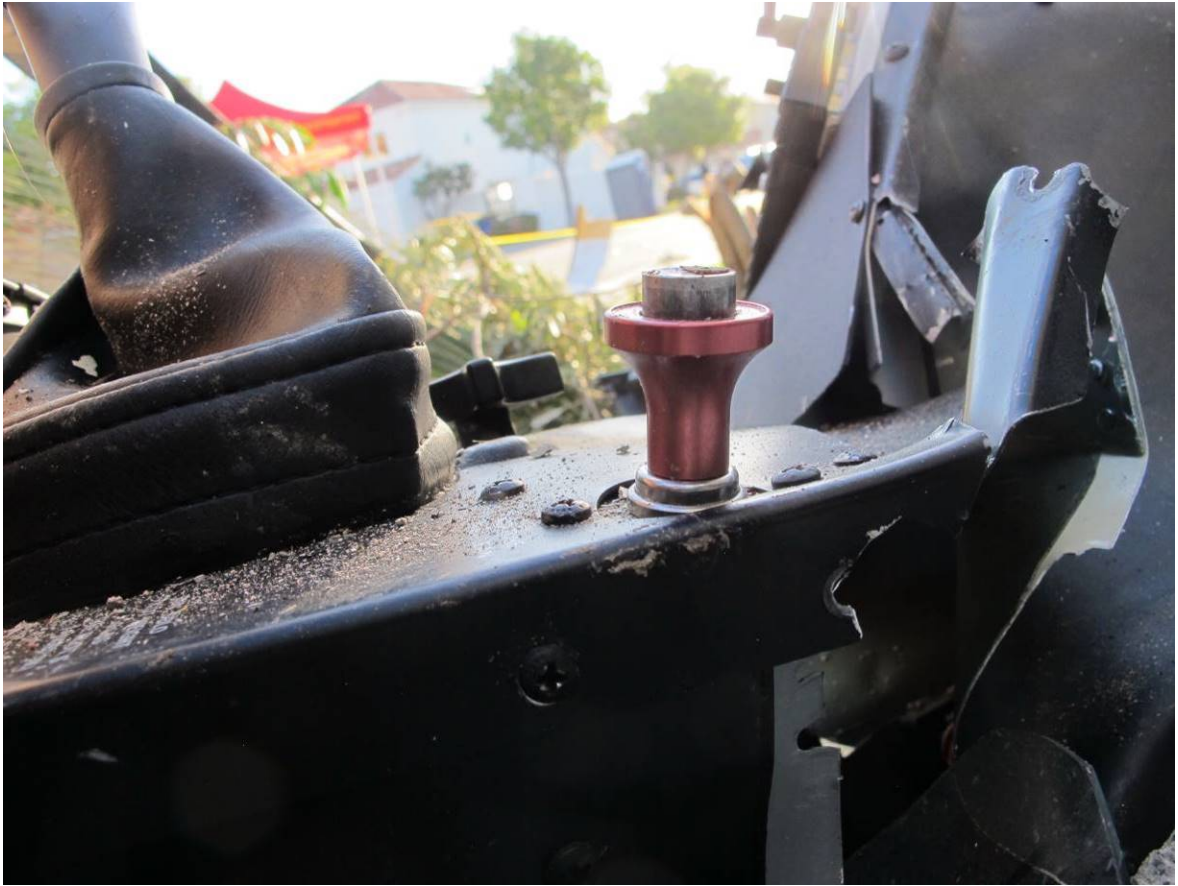
The fuel mixture control knob was in the full rich position. The fuel mixture control knob guard was recovered near the cabin. The fuel mixture control arm on the carburetor was in a full rich position and moved freely yet the control wire was detached from the fitting. The hardware on the fitting was secure. The return spring was in place. The fuel mixture control wire sheath was secure in the mounting clamps on the mount. The mount was separated from the airbox.

The fuel mixture control knob
